**NIOSH**  
Fire Fighter Fatality Investigation  
and Prevention Program

A summary of a NIOSH fire fighter fatality investigation

March 2, 2016

### *Lieutenant and Fire fighter Die and 13 Fire Fighters injured in a Wind Driven Fire in a Brownstone - Massachusetts*

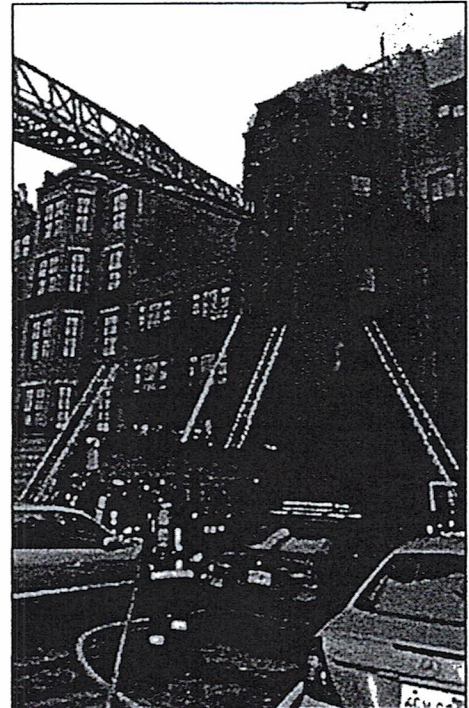
A view of fireground worker leaving the rear door of the attached shed open while investigating the smoke detector activation. The conditions became untenable for the fire fighters from Engine 7. They moved out of the building to the landing of the front steps. Also, the interior door at the top of the basement stairs was open, the front exterior doors were left open by an occupant fleeing the fire, and a rear basement door or window failed. Once the rear door or window burned through, this created an unrestricted flow path from the basement to the first floor plus
