NURSING HOME FIRE
Norfolk, VA
October 5, 1989

**FINAL FIRE INVESTIGATION REPORT
NURSING HOME FIRE
NORFOLK, VIRGINIA
October 5, 1989
12 Fatalities**

**Prepared By
Thomas J. Klem
Director
Fire Investigations Division**

(Revised October 1991)

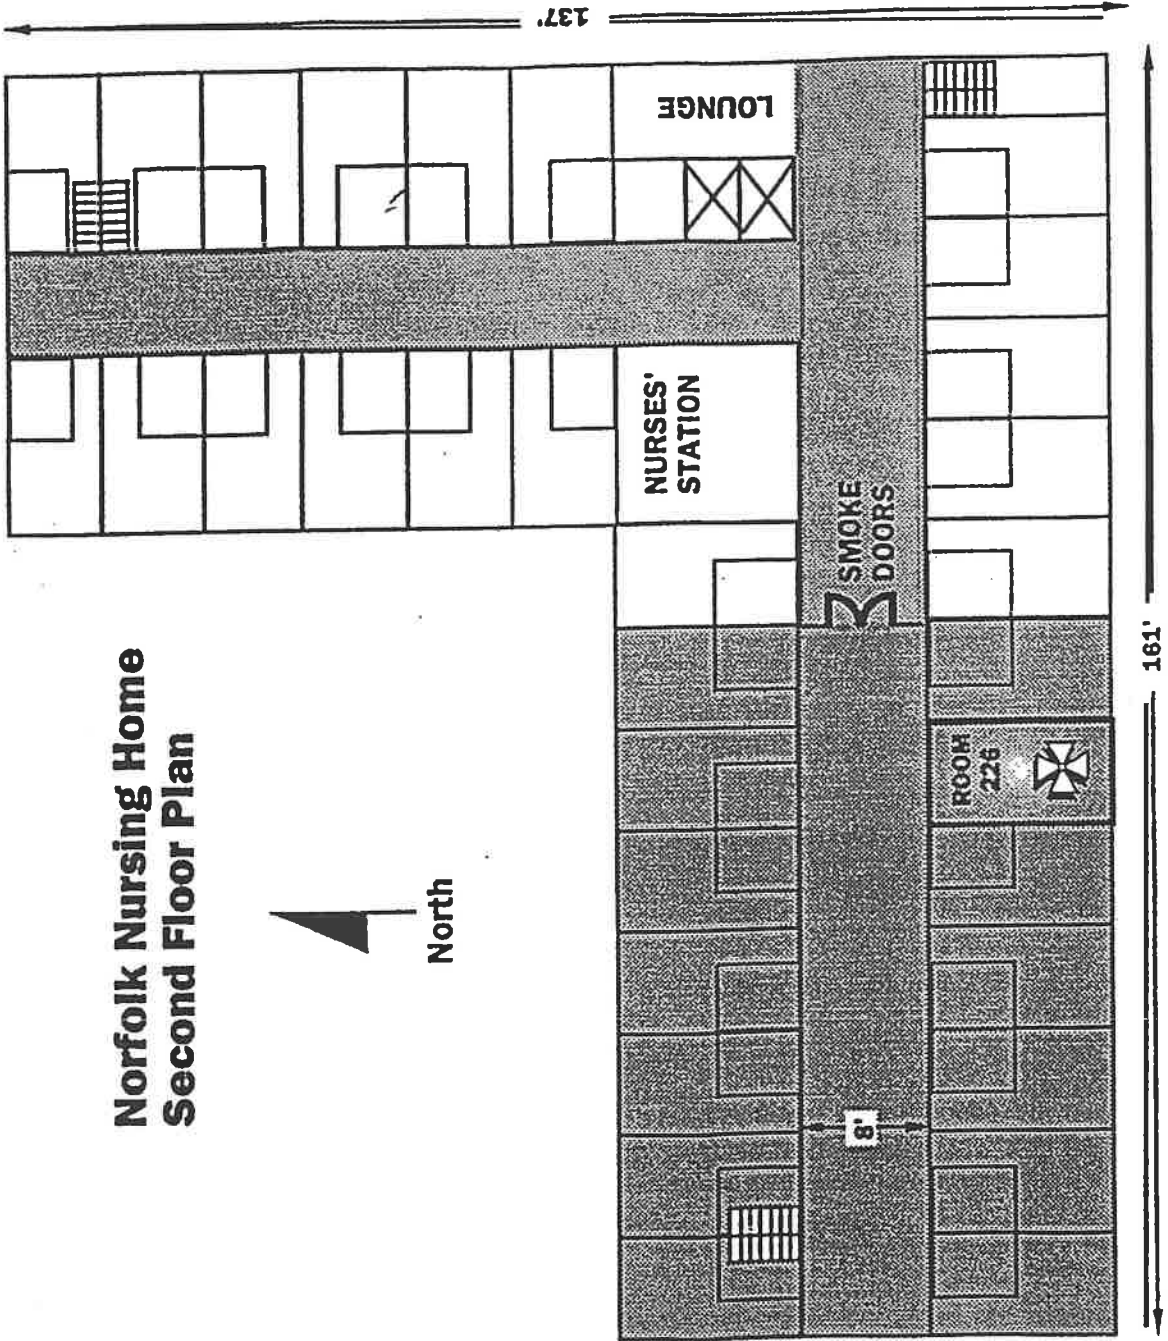
Norfolk Nursing Home Second Floor Plan

Each floor of the building was divided into two separate smoke zones utilizing an interior partition and smoke barrier doors (see diagram). The smoke barrier doors, positioned in the exit access corridor, were held in the open position by magnetic hold-open devices; a component of the fire alarm system (see later description). Although a fire resistive barrier was provided above the smoke barrier doors to fill the void to the floor deck above, the partition did not extend above the suspended ceiling in adjacent patient rooms.
