# Fire Strikes Las Vegas High-Rise

**By Kenneth Morgan**

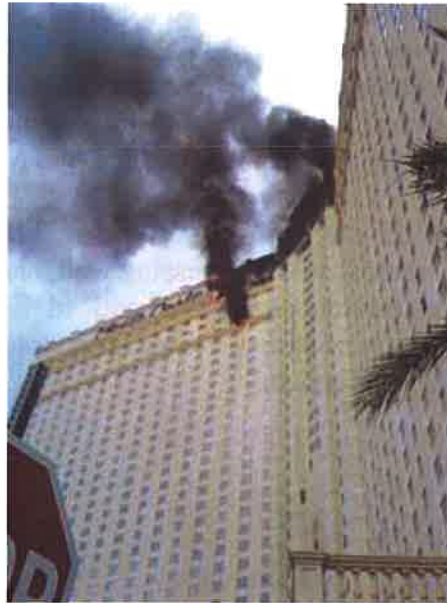
Engine 11 (E11) arrived at 1100 hours and confirmed that there was definitely a fire and that it appeared to be on the exterior of the structure (photo 2). E11 requested a second alarm, duplicating the first alarm. B2, on hearing the report and seeing the smoke rising from the strip, ordered a third alarm at 1101 hours. [Photo 3 shows the view from the A side (Las Vegas Boulevard) of the structure.]

*(2) The fire from ground level. (Photo by Dave Connell.)*

The fire was burning in a decorative polystyrene foam material with a stucco-like finish, attached to the exterior of the building (it ranged from three to 12 inches in thickness, depending on the location). This foam was part of the exterior architectural façade, which was then covered with material to match the exterior design. At the top of the structure was a false wall approximately 25 feet tall. This made access to the exterior from the roof difficult; limited access points were available to get streams onto the fire. As the fire burned this material, large amounts of smoke and heat were generated, which eventually breached the windows on the 32nd floor, allowing the fire access to the interior of the building.

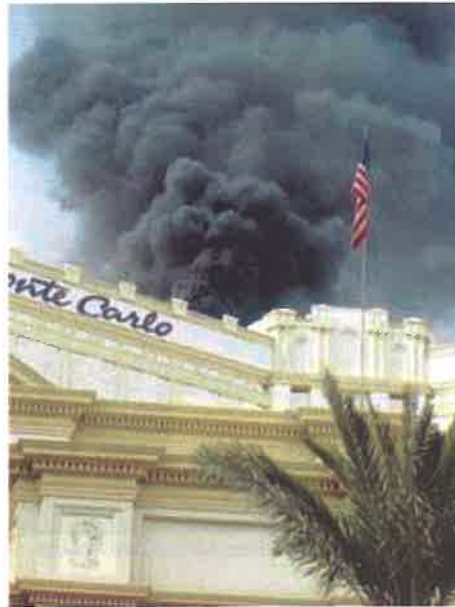
*(3) The view from Las Vegas Boulevard. (Photo by Ryan Glassford.)*

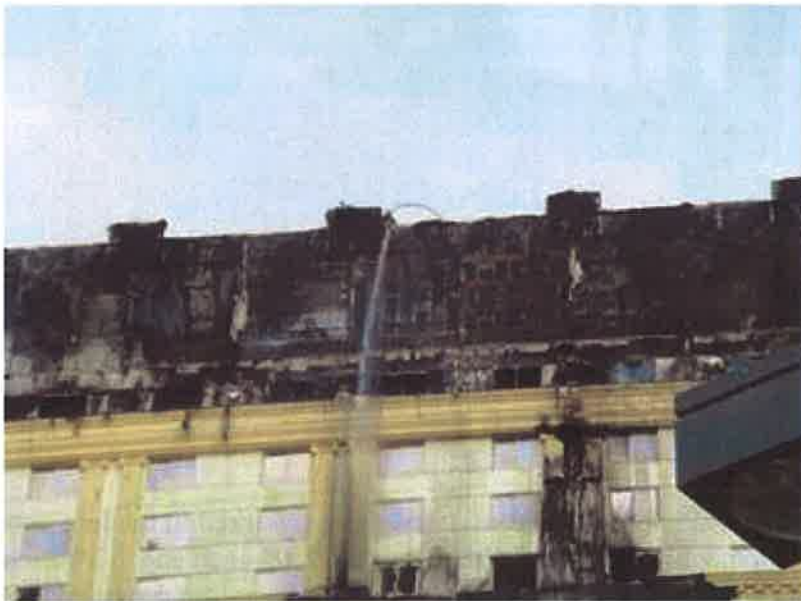
This structure was on the approach path for a heliport, which created another issue for roof operations (photo 6). This downwash created a safety issue as the helicopters buffeted the firefighters and increased the amount of falling debris. Through the Las Vegas Metropolitan Police (MPD) and the McCarran International Airport air control, these distractions were eventually prohibited within one mile of the resort. Other issues were created by the flaming debris, which started several spot fires on adjacent roofs.

*(6) Roof operations. (Photo by Kenny Holding.)*

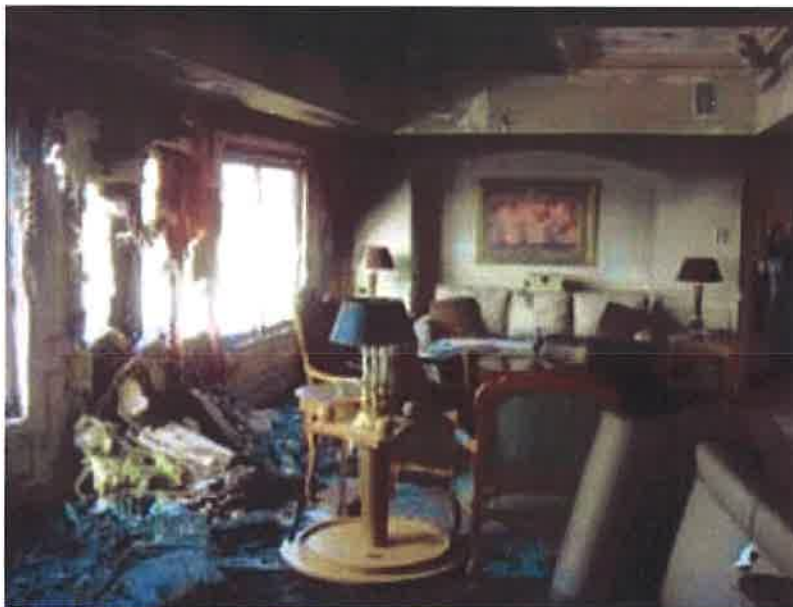
As a result of the MGM fire in 1980 and the Hilton fire in 1981, Nevada has some of the toughest high-rise fire safety regulations in the country. These life safety systems paid off at the Monte Carlo fire. Despite fire gaining access to the structure at two levels, sprinkler systems activated and kept the fire in check until suppressions crews could gain access (photo 7) and suppress the fire (several heads operated on the 27th and 32nd floors). Sprinklers assisted interior crews, and the focus changed to extinguishing the exterior area. Crews on several floors forced windows and attacked from these vantage points. The problem was locating a window that would not allow extension into the structure but would provide a good point from which to extinguish this fire. Then, there was the concern for placing a firefighter halfway out a window 29 floors aboveground. Several firefighters were secured with safety lines while operating from the roof over the side of the building.

*(7) Fire breached the structure. (Photo by Joseph Dodd.)*

The Monte Carlo was undergoing an improvement project to install walkways along the roof areas. The project, which was contracted to a private firm, involved cutting corrugated steel products with a cutting torch. Hot molten metal from the operations most likely ignited the foam product, starting the fire. The foam's flammability created a fast-spreading fire that was difficult to control.

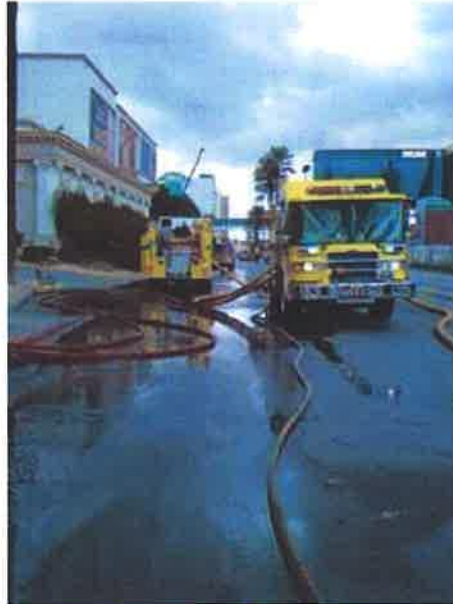
To make pressures sufficient at the roof, two engines worked in tandem operation to pump the standpipe, which in turn supplied several 2 1/2-inch and 1 3/4-inch hoselines off the roof manifold and in the stairwells (photo 8). This operation provided more than enough water to gain control of this incident. The smoke evacuation systems (a post-MGM Grand fire code requirement), designed to exhaust the “fire floor” and pressurize the floors above and below, worked flawlessly to remove combustion products from the

*(8) Tandem pumping at 340 psi. (Photo by Kenny Holding.)*

- There are no routine fires! This fire proved challenging for several reasons.
  - High-rise procedures don't account for fires on the structure's exterior.
  - Large high-rise buildings require unusual standpipe pressures. Plan for this to prevent system damage and to adequately supply crews.
